HISTORIC STRUCTURES REPORT
ARCHITECTURAL DATA SECTION

February 1986

JACOB RIIS BATHHOUSE EXTERIOR
JACOB RIIS PARK HISTORIC DISTRICT
GATEWAY NATIONAL RECREATION AREA
NEW JERSEY/NEW YORK

by
John B. Marsh
and
Sally Small

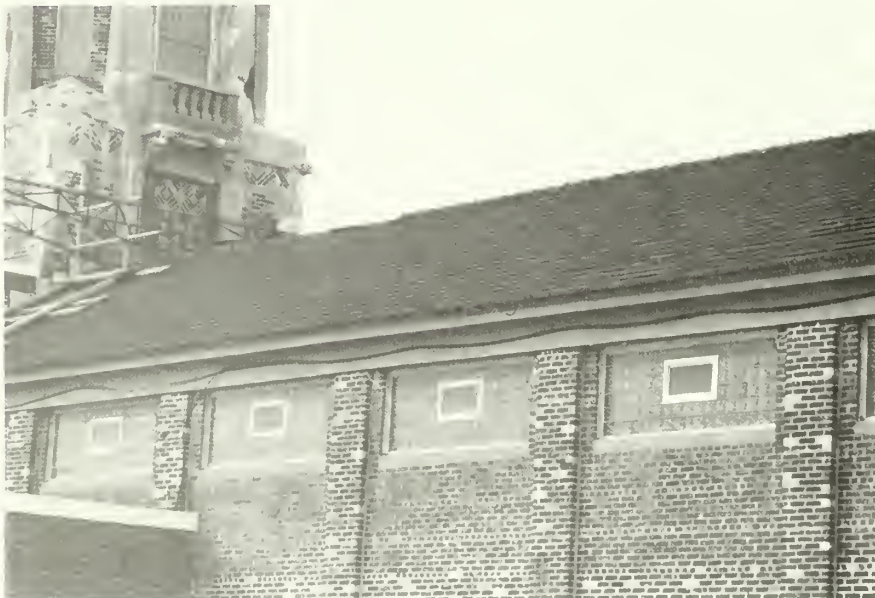
1953 drawing.²⁰ The current roof finishes are a green scored terra-cotta (ceramic veneer) tile (Figs. 8 and 9). Some repairs have been made to the tiles over the years but the roof is in generally good condition. A few tiles are cracked, broken or missing and portions of the ridge cap are missing, but these have not developed into serious problems. A few minor leaks have resulted from the broken tiles and faulty flashing at the base of the towers, but these can be corrected with repairs (Figs. 8 and 9).

Figure 8: Ceramic veneer (terra-cotta) the roof finish at Beach Pavilion. Note missing ridge coping to left. Broken tiles lay under scaffolding.
NPS photo, October 1985.

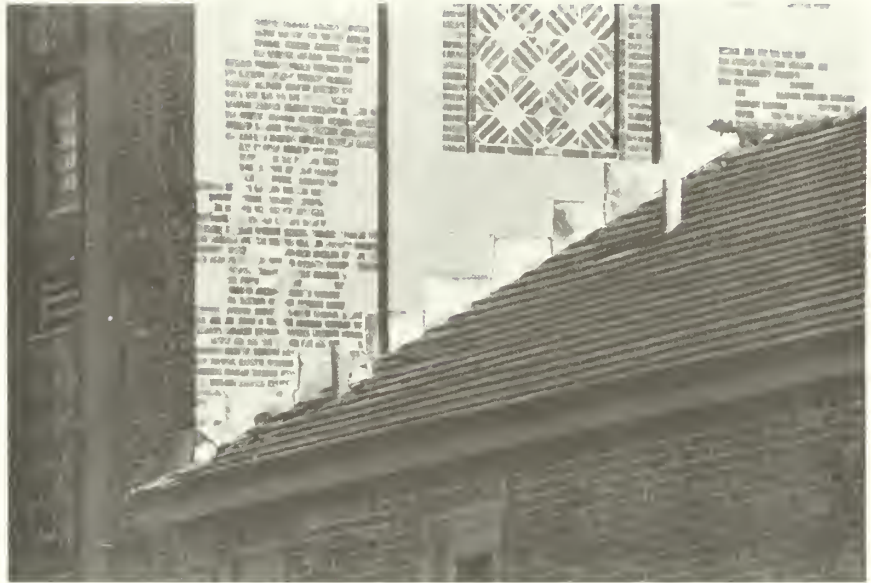
Figure 9: Faulty counterflashing at base of West Tower. Flashing pulling out from joints in wall. Joints needs repointing.
NPS photo, October 1985.

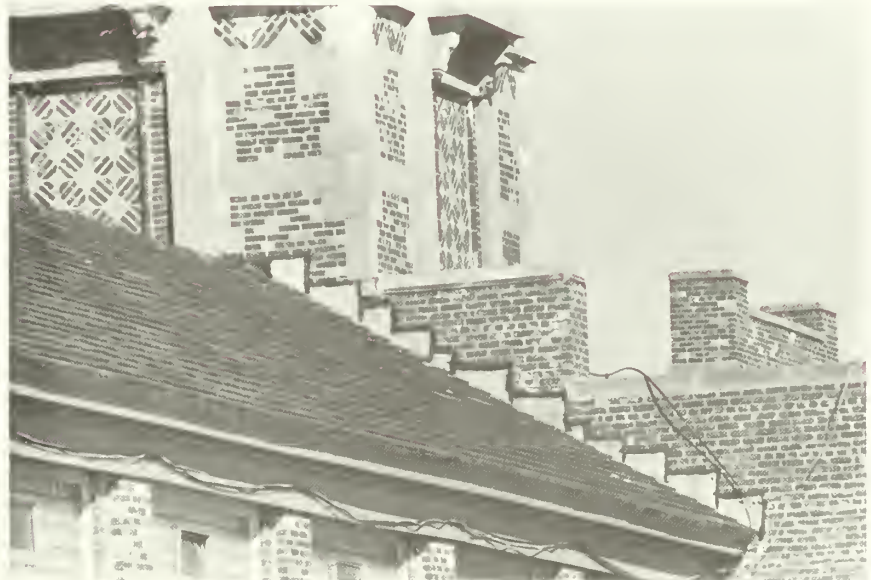
Along the roof's edges drip flashing is rusting or missing (Figs. 9 and 10). The flashing is contributing to the leaking problems and should be replaced with suitable materials which would endure the salt-laden environment.

Figure 10: Rusting drip flashing at roof edges, West Tower. Note cornice and eaves below, and faulty counterflashing at base of tower. Tar at joints of flashing is deteriorating.
NPS photo, October 1985.

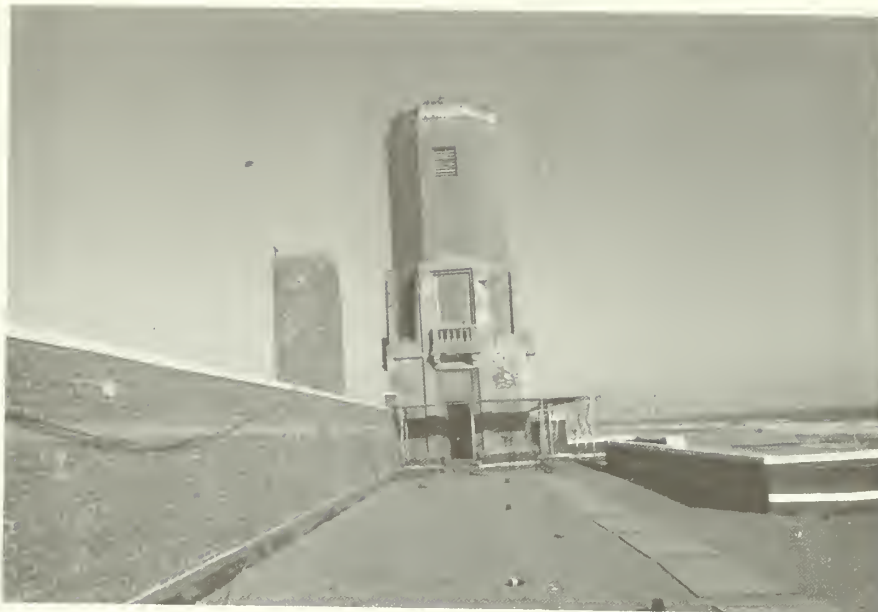
Figure 11: Built-up roof of Part 2 looking east. Worn areas of roof found to have water below surface of felt. East Tower in background. NPS photo, October 1985.

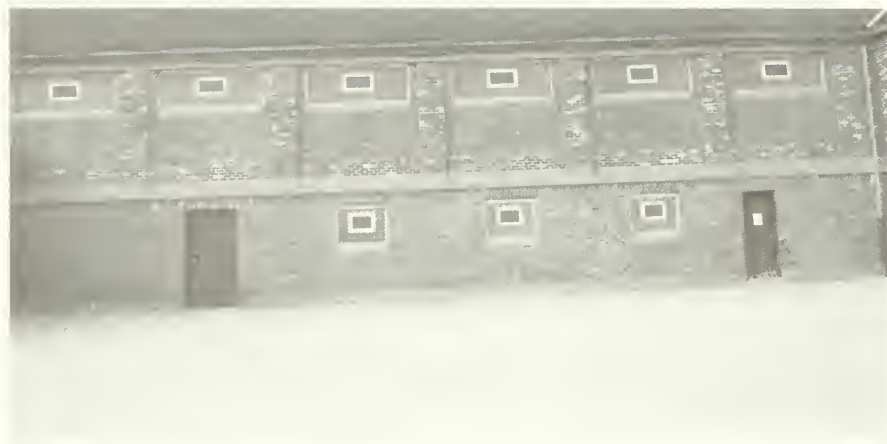
Figure 21: South Elevation--Part 3. Lintels between windows rusting and damaging walls between them. Conditions prevail at first floor of this facade.

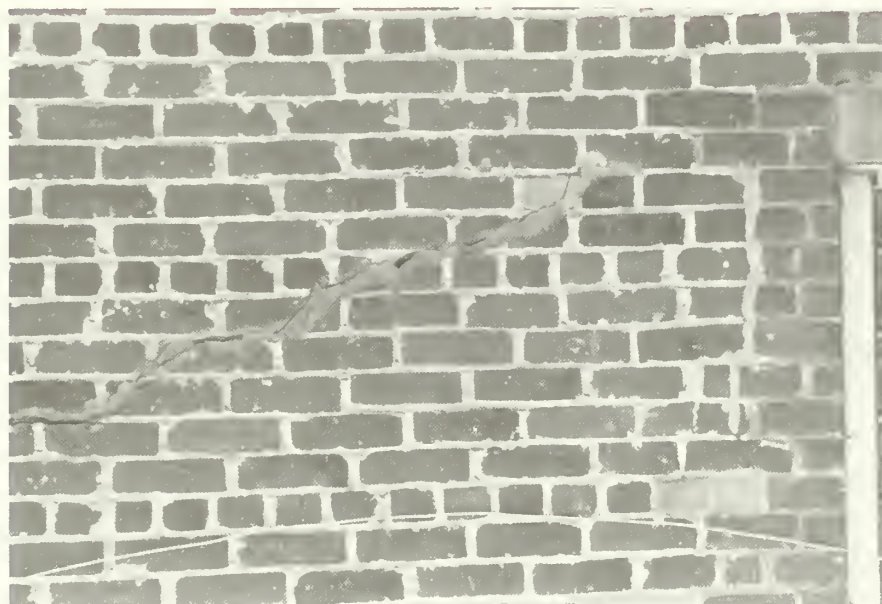
Figure 22: Typical condition of repaired cracks. Cracks are reopening.

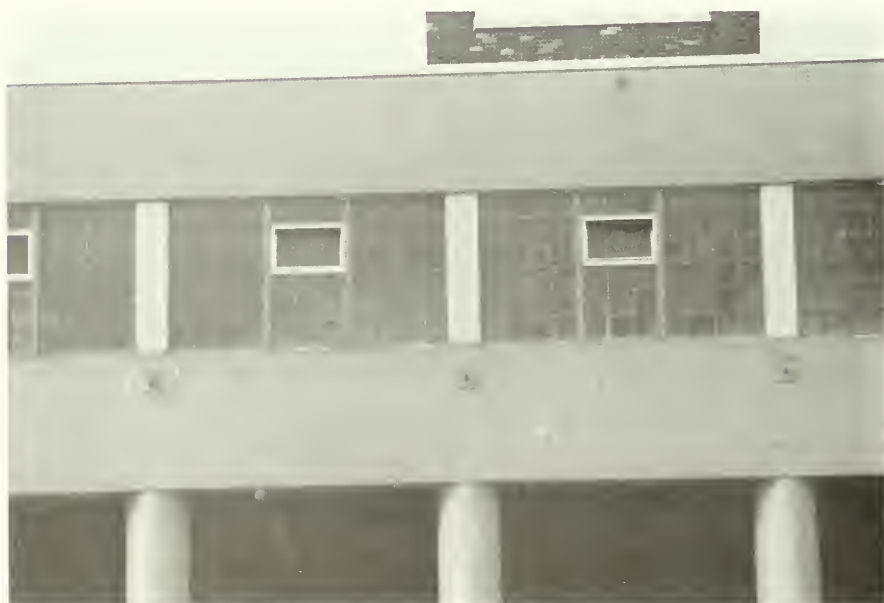
Figure 24: Elevation of loggia (North Elevation--Part 2). Note typical glass block windows with vents used throughout the Beach Pavilion. Problems of concrete in beams, columns and ceiling typical.
NPS photo, 1985.

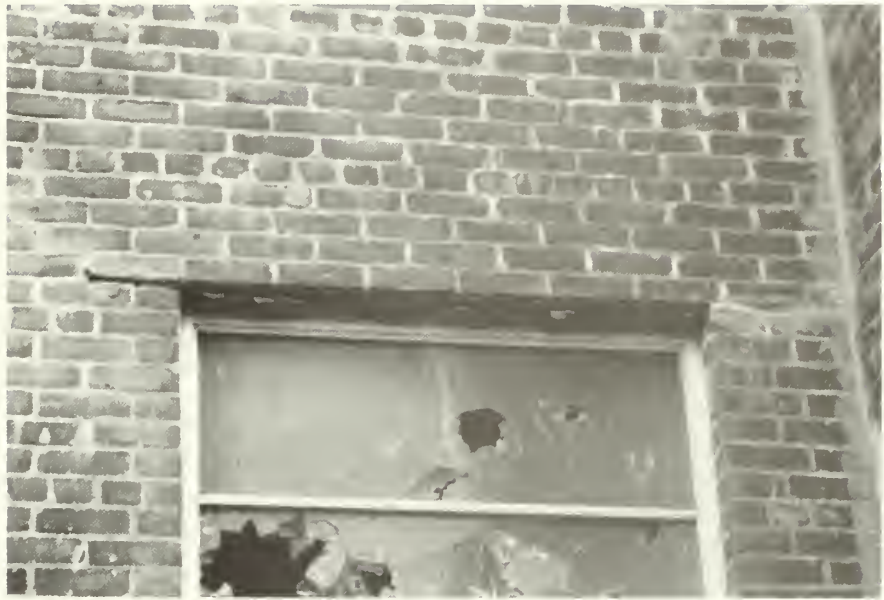
Figure 25: Typical aluminum projected window at Pavilion. Only a few remain. Note also rusting lintel above. Rusting lintels typical but worst at some windows.
NPS photo, 1985.

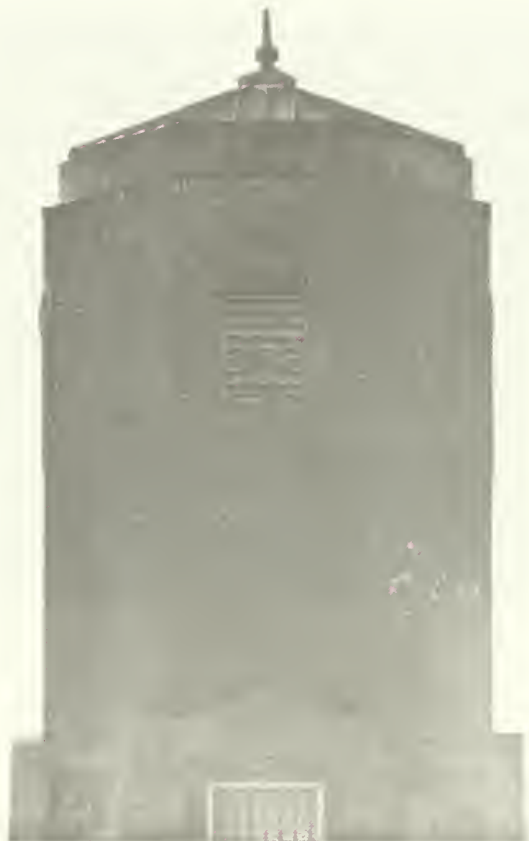
Figure 26: Tower roof--typical at East and West towers. Roofs leak between top of wall and roof finish, and at hatchway.
NPS photo, October 1985.

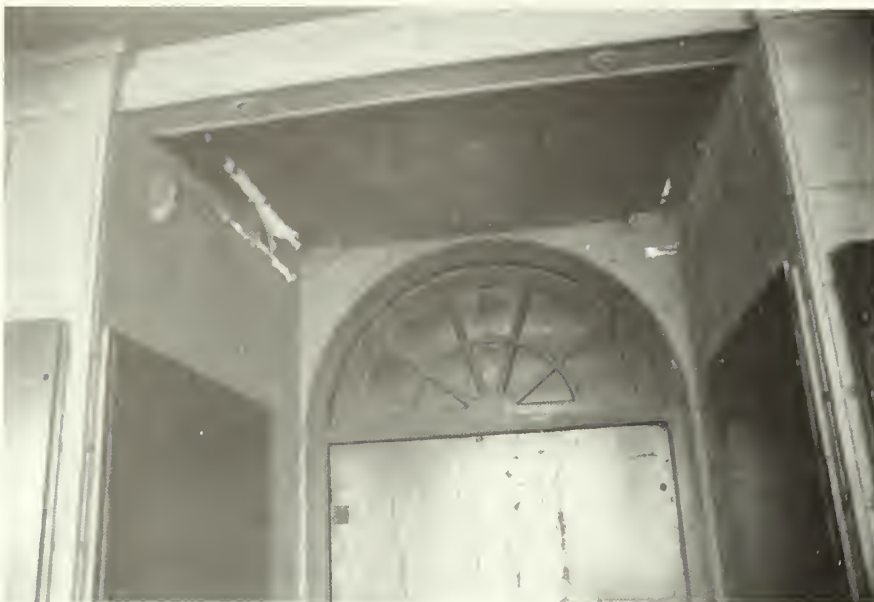
Figure 39: Plaster molding damage at door 410, Entrance Pavilion.
NPS photo, 1985.

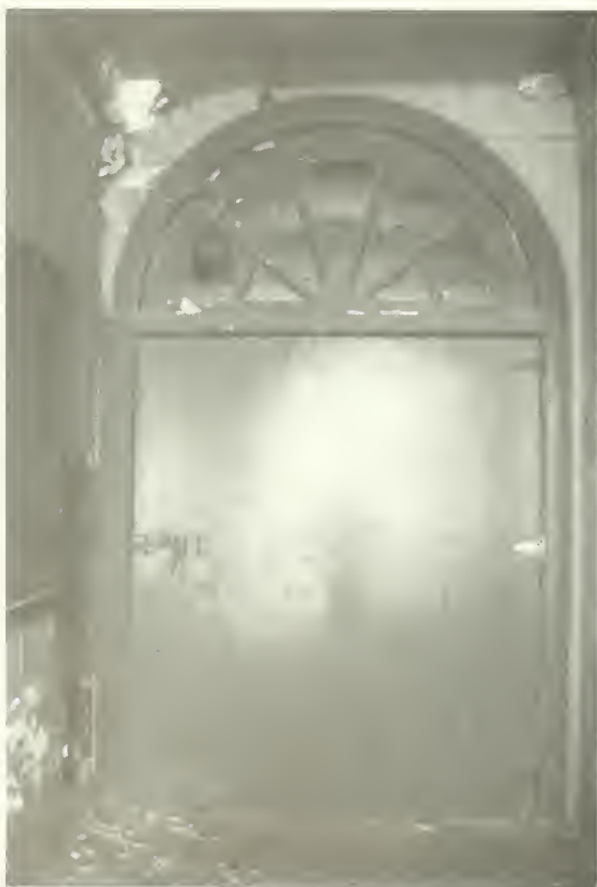
Figure 40: Plaster wall deterioration at door 409, Entrance Pavilion.
NPS photo, 1985.

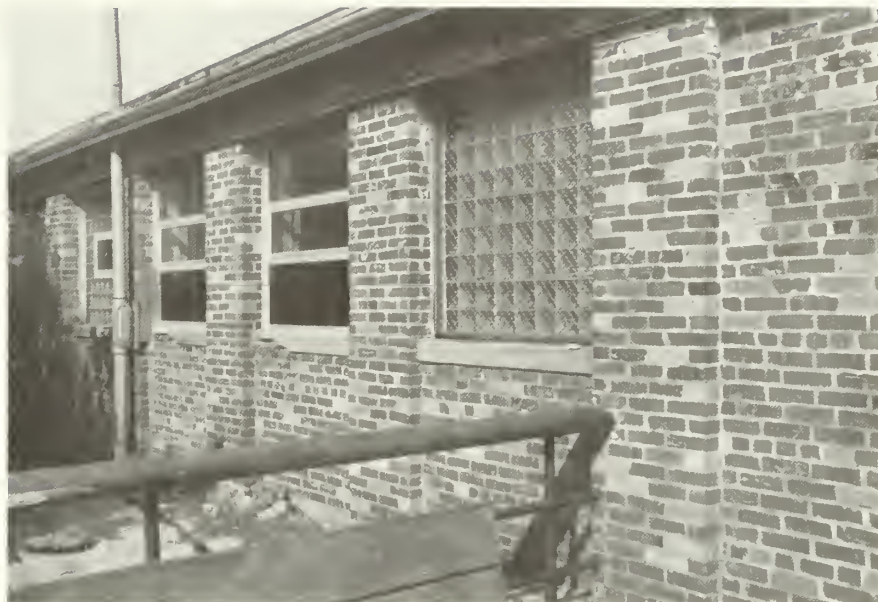
Figure 65: West Wing, West Elevation, showing spalling sills at windows 509, 510, and 511. NPS photo, 1985.

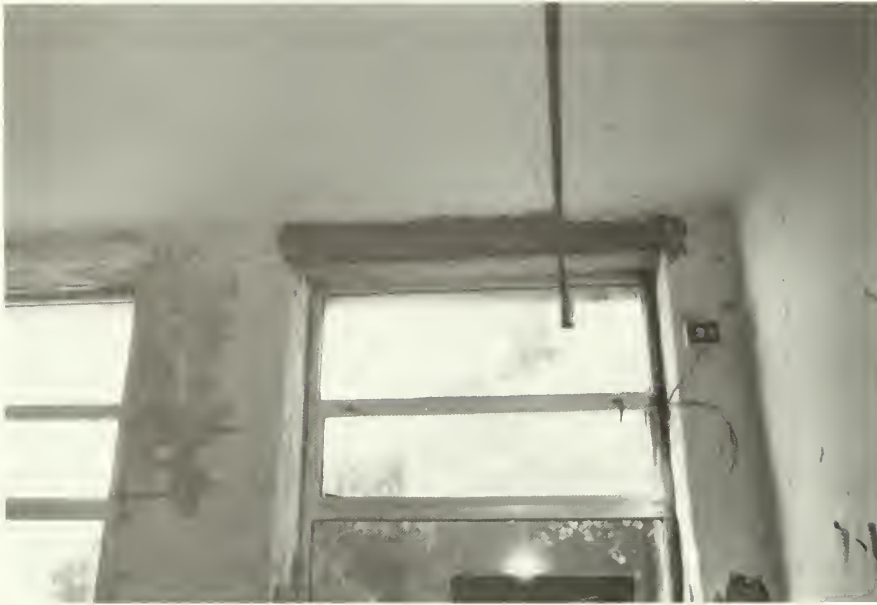
Figure 67: Water damage at Windows 510 and 511, West Wing. NPS photo, 1985.

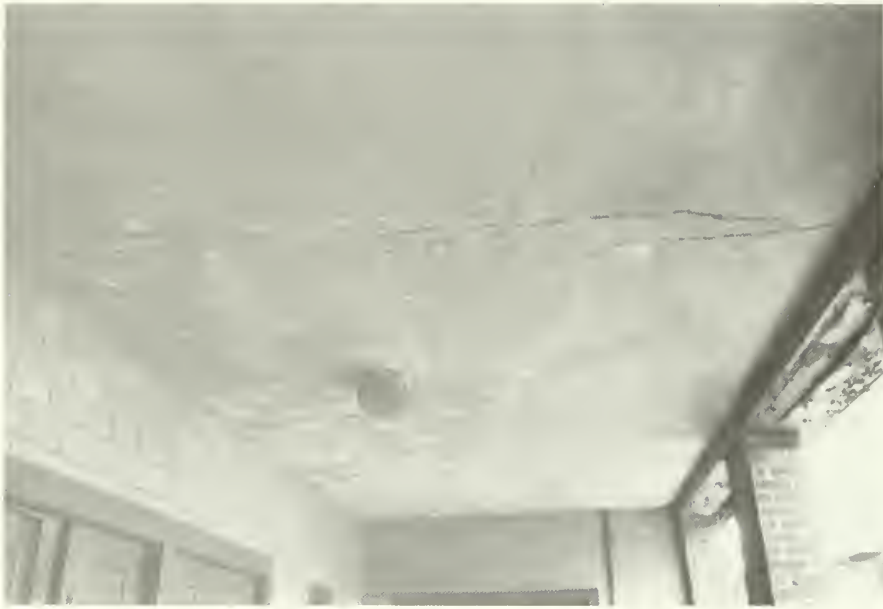
Figure 71: West Wing loggia, cracks in ceiling.
NPS photo, 1985.

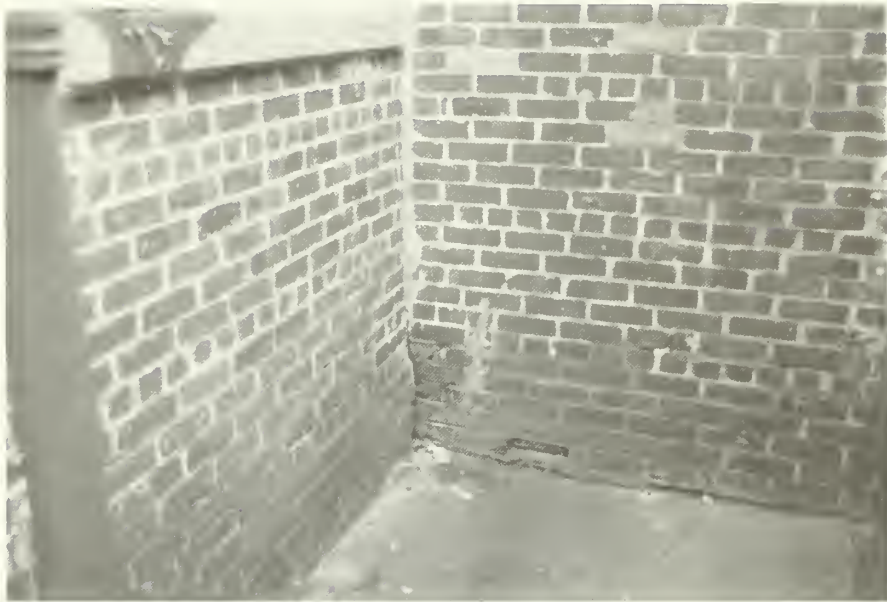
Figure 79: Wall bowing out under Window 618, East Wing.
NPS photo, 1985.

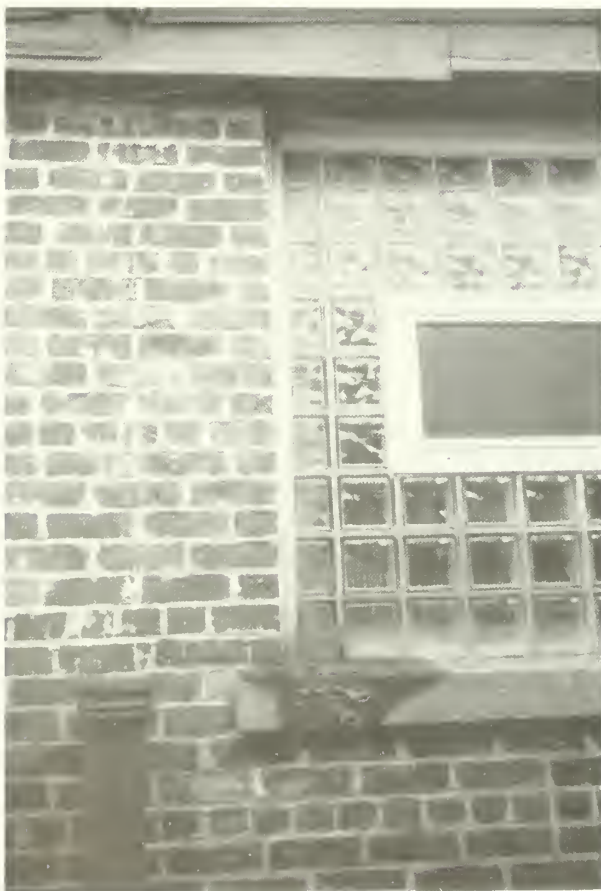
Figure 80: Dark stain and waxy efflorescence at Window 618, East Wing.
NPS photo, 1985.

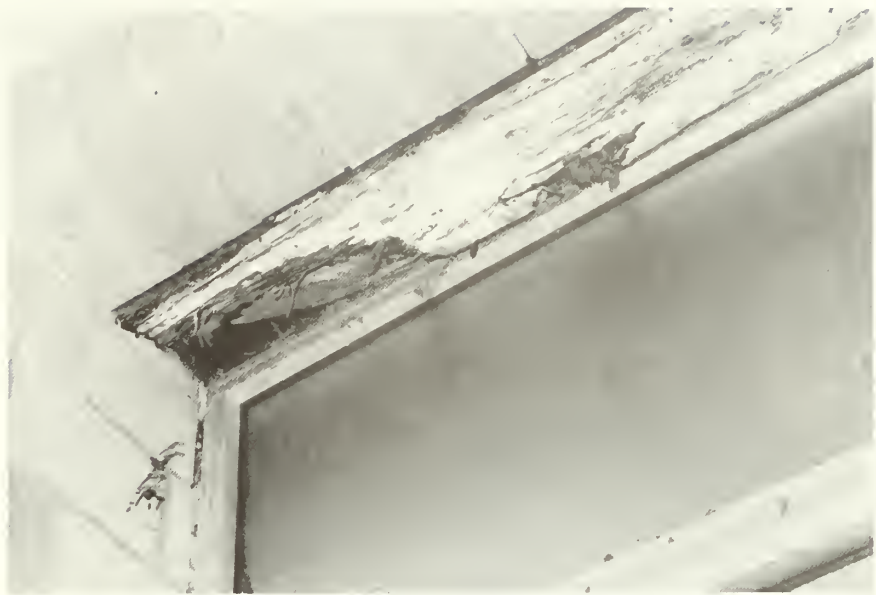
Figure 81: Rotten lintel at Window 629, East Wing.
NPS photo, 1985.

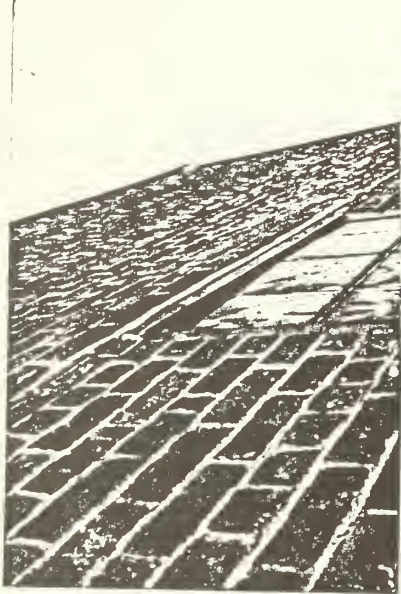
1. Typical 'jacking' effect of deteriorating steel lintel at Beach Pavilion.

If a sufficient amount of base metal remains, the lintels and pier reinforcing can be scraped free of rust scale and retained. If the remaining base material is structurally inadequate, then the units must be replaced. Without the benefit of numerous probes, it is estimated that most of the lintels will require replacement. New steel should be galvanized and reconditioned steel painted.

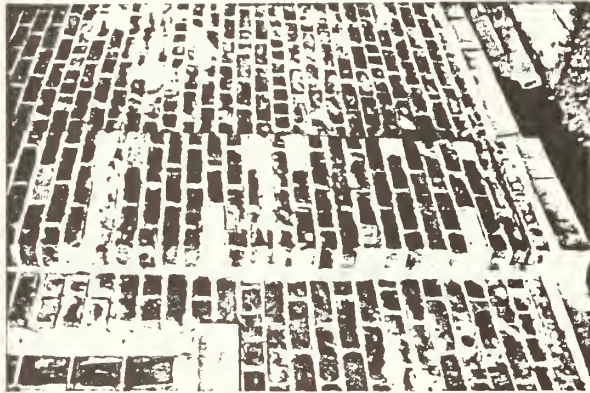
2. Rusted reinforcing in masonry pier, typical at Beach Pavilion.

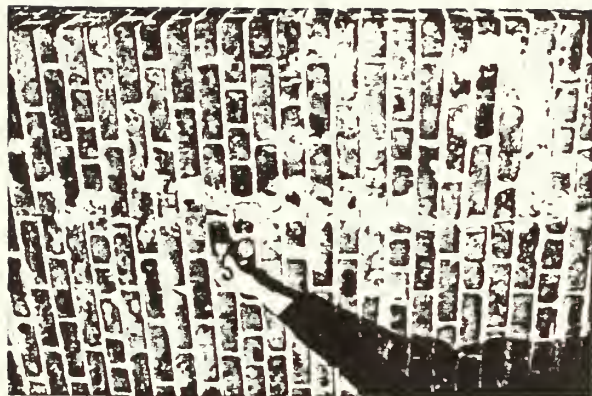
2. The face brick of the exterior wall is cracked and face-spalled. (See photo #5.) The cast stone is also cracked, spalled, and in some areas the reinforcing bars are exposed and rusted. Mortar joints are generally satisfactory.

5. Typical cracked and spalled brick at Beach Pavilion.

To prevent further deterioration after individual damaged units are repaired or replaced, the wall can either be reparged, painted, or treated periodically, perhaps with transparent sealants.

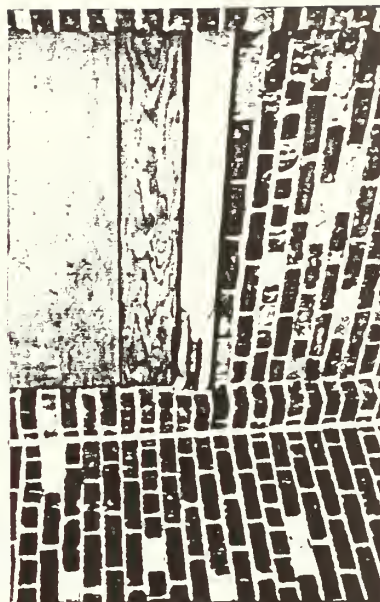
6. Typical cast stone deterioration at Beach Pavilion.

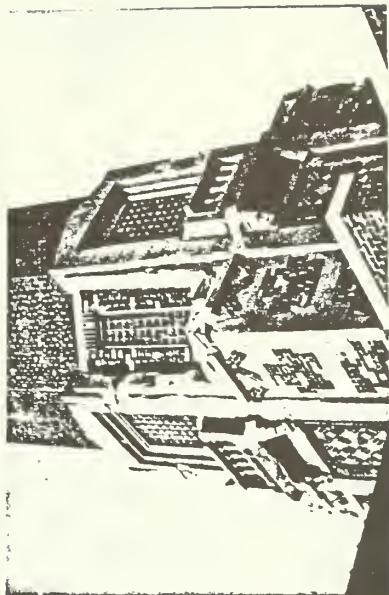
7. East tower - Cast Stone and Brick Deterioration.

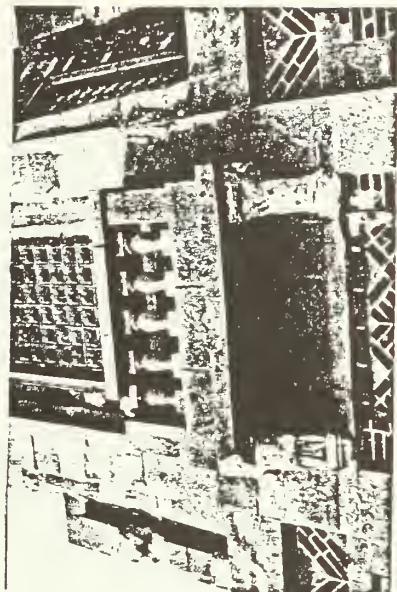
10. West tower cast stone deterioration at balcony.

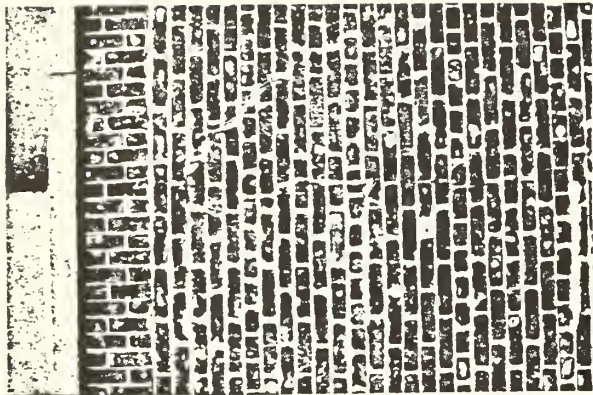
5. As a result of the foundation being a combination of piles and spread footings, cracks have occurred in the exterior walls and the interior structure. (See photo #12.) Some are controlled and others are not. These joints and cracks must now be treated as expansion joints using appropriate details and materials.

12. Typical crack in brick masonry wall at Beach Pavilion.

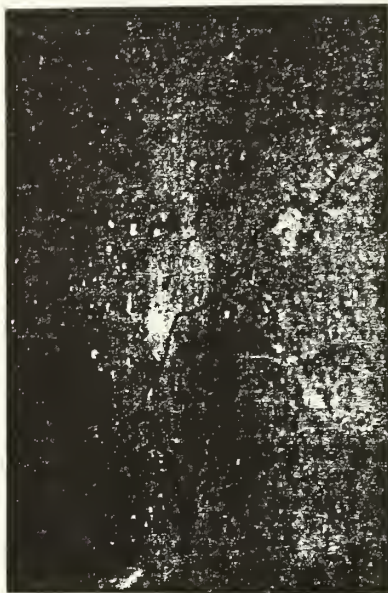
A crack has developed in the floor at the second level between the original structure and the added kitchen wing. (See photo #13.) Since the kitchen wing is supported on spread footings and the original building on piles, this joint shall be assumed to be kinetic and should be modified to become an expansion joint.

13. Crack at second floor between original structure and 1937 addition.

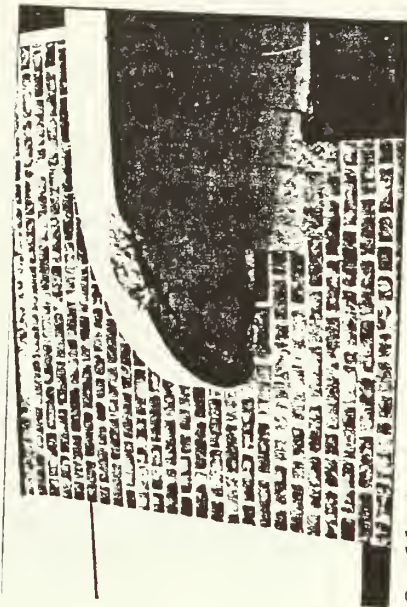
14. Spalled concrete canopy at Beach Pavilion.

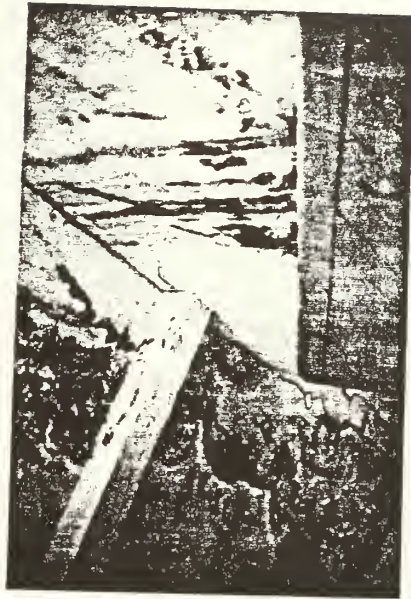
7. There is peeling paint, spalling plaster, some spalling concrete and minor rusting at the interior structure, especially in the stair areas, none of which seems to have significantly affected the structure (see photo #15). Probes are required in the worst of these areas to verify these findings.

15. Peeling paint, spalling plaster, spalling concrete, and minor rusting of reinforcing.

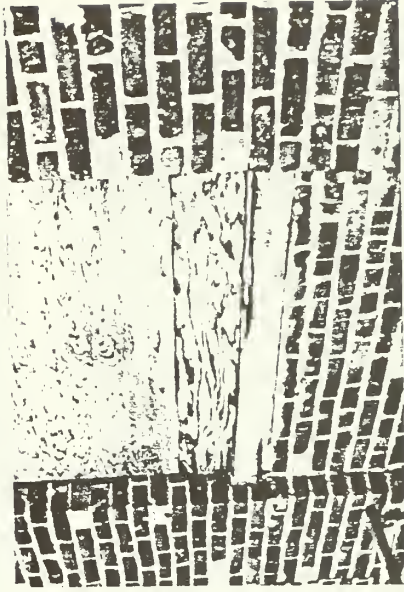
17. Cast stone window sill at West Wing showing typical condition.

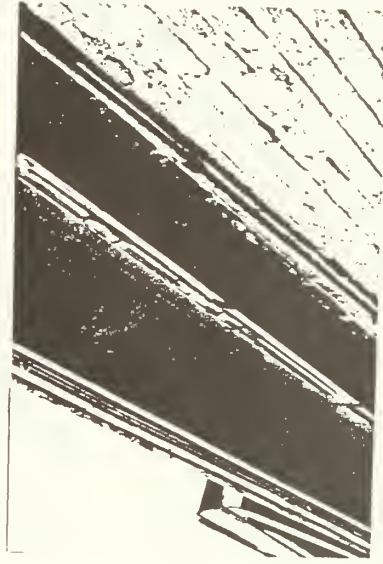
19. Court-side eave condition at West Wing.

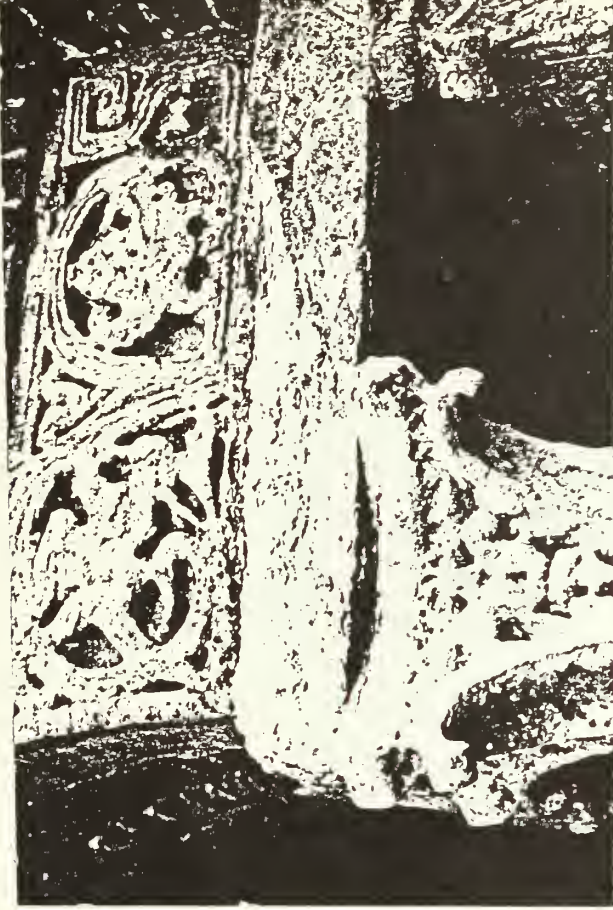
22. Detail of spalled cast stone at Entry Pavilion.

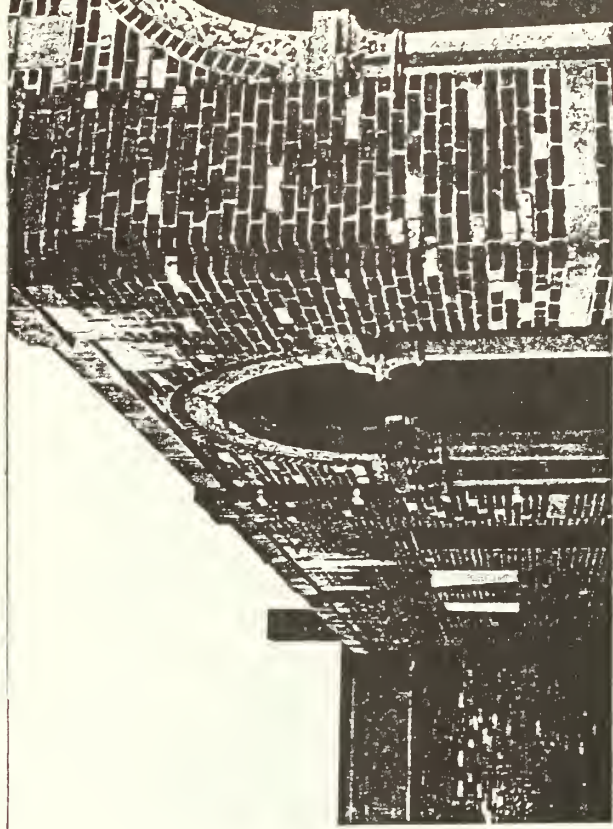
4. The east parapet is rotated outward slightly and is unstable. (See photo #23.) Repairs are required but more importantly the condition causing the rotation must be corrected.

23. View of east parapet of Entry Pavilion. Note efflorescence and slight bowing of parapet wall.
